MTB - WARNING!

Ensure Clearance
Between Wheel &
Aeroclam.

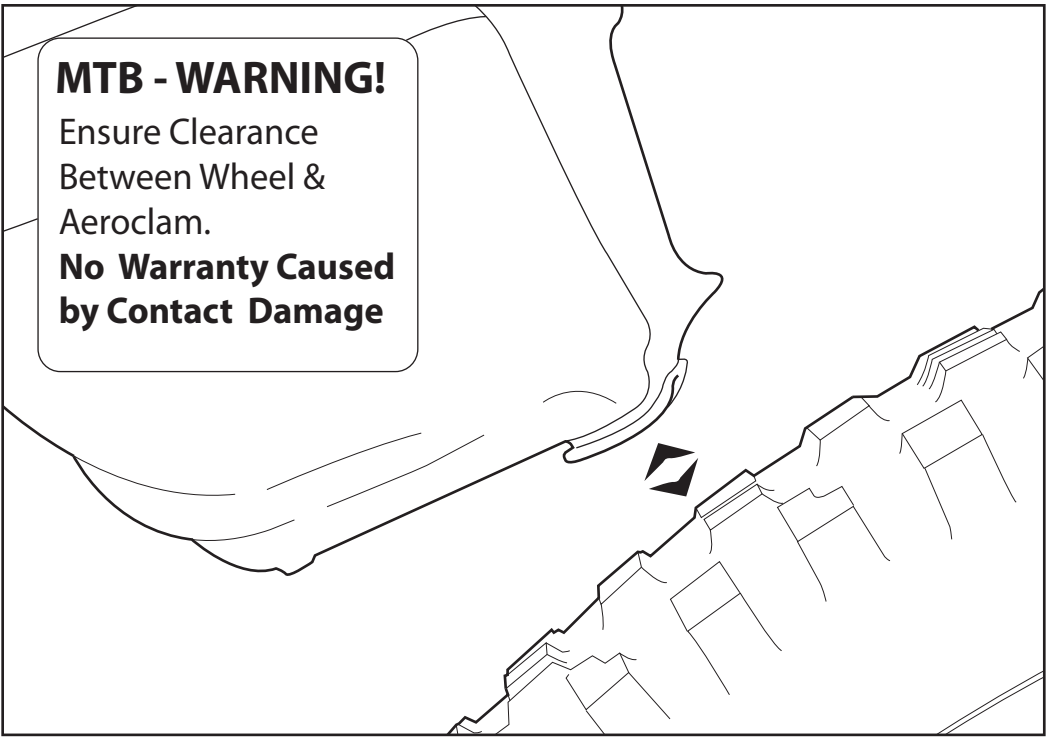
**No Warranty Caused
by Contact Damage**

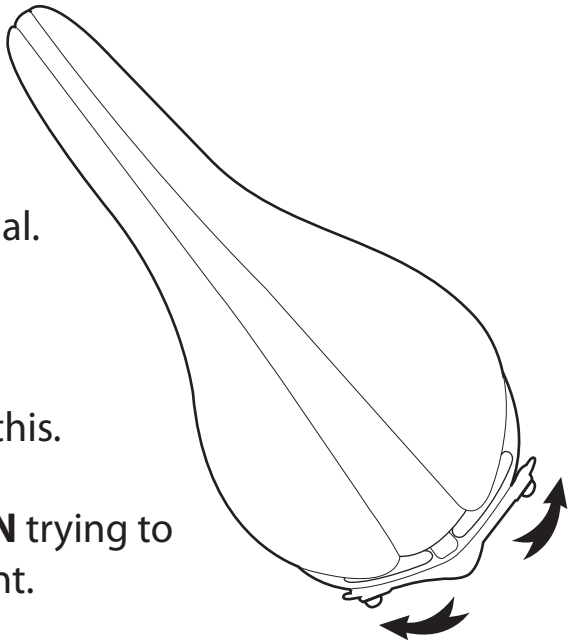
Movement

Slight side to side
movement at the rear
of the Aeroclam when
tightened is quite normal.

Especially so with the
thinner metal seat rails.
It's Designed to be like this.

DO NOT OVERTIGHTEN trying to
eliminate this movement.
